Release Notes for iCube Control Products

Release 2024.3.1

Date: 2024-10-07

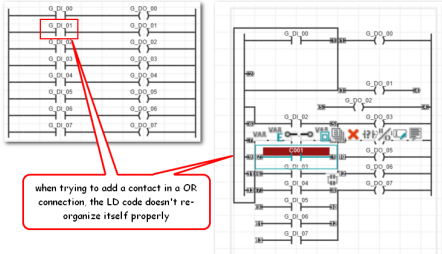
47608	LD Network Graphics Incorrect	<p>Modify ladder diagram rung with common power rail can bring organization display issue as follows.</p>

<p>Make space in the ladder diagram before inserting the OR connection

<p>OR</p> <p>Do not make the power rails continuous for multiple rungs.</p>

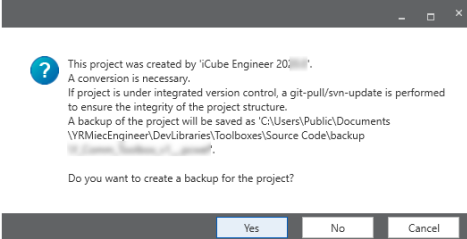
49501	iCube Engineer 2024.3 removes the POU of a project build in earlier versions during project conversion	<p>When converting a older version project into iCube Engineer 2024.3, with the following pop up :</p>

<p>One of the possible reason other than the maximum length is that the POU, FB or datatype worksheet have been renamed in the previous iCube Engineer version with the same string name but different font case, example :</p> <p>"pou_1" replaced with "Pou_1".</p> <p>During the conversion the link between the component tree and the file is then lost afterward.</p>	<p>rename the file accordingly to the component item name in the older iCube Engineer version.</p> <p>The file should be contained into <Project Name>/content/...</p> <p><i>note: when using *.pcwex format, the file needs to be unzipped to find the "content" folder.</i></p> <p>Then open in the new iCube Engineer version and proceed to the conversion of the project again.</p>

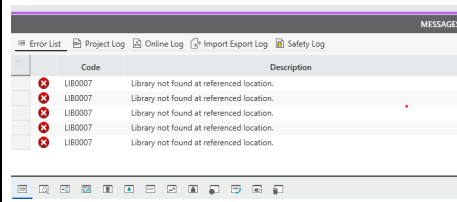
In case the administrator and the local user are two different accounts, and iCube Engineer is being opened from the normal user, the following error will occur: "Library not found at referenced location".

There are 3 possible workarounds in this situations:

1. Start iCube always in *Run As Administrator*, in this case the the default path to look for user libraries in iCube will change to C:\Users\- 2. Incase you don't want to Run the iCube in Run as Administrator then after running iCube change the path in the iCube software where it looks for the user libraries. For this go to *Extras->Options->Tools->Directories->User Libraries location*.
- 3. Copy the library from the administrator folder to the user folder.

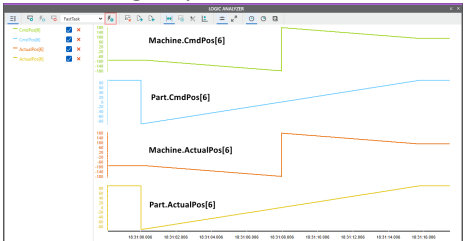
<p>Also, PCS movements where the rotational axis' position crosses 0 might cause a jump in the MCS position, as seen in the following image. The servo will throw an alarm in such a case, stopping the motion of the whole group.</p>

<p>Some possible workarounds are:</p> <ul style="list-style-type: none"> • Do not use a PCS coordinate system • Select target positions that avoid conflicting trajectories • Add middle positions commanded in MCS to avoid conflicting trajectories
