Release Notes for iCube Control Products

Release 2024.3.1

Date: 2024-10-07

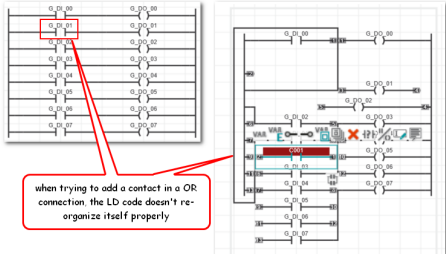
47608	LD Network Graphics Incorrect	<p>Modify ladder diagram rung with common power rail can bring organization display issue as follows.</p>

<p>Make space in the ladder diagram before inserting the OR connection

<p>OR</p> <p>Do not make the power rails continuous for multiple rungs.</p>

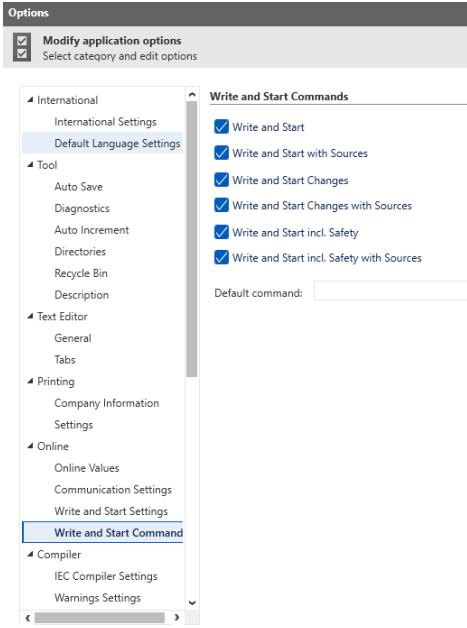
49305	Software crashes when selecting 'Write and Start incl. Safety' from the Write and Start Commands config	<p>iCube Engineer crashes if the Write and Start commands are edited from the Extras > Options menu in iCube Engineer's home page. (without opening a project)</p>

Modify the Write and Start Commands settings from the Extras > Options menu in an already opened project.

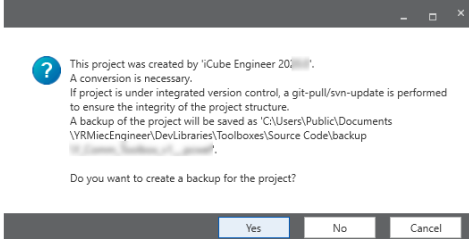
49501	iCube Engineer 2024.3 removes the POU of a project build in earlier versions during project conversion	<p>When converting a older version project into iCube Engineer 2024.3, with the following pop up :</p>

<p>One of the possible reason other than the maximum length is that the POU, FB or datatype worksheet have been renamed in the previous iCube Engineer version with the same string name but different font case, example :</p> <p>"pou_1" replaced with "Pou_1".</p> <p>During the conversion the link between the component tree and the file is then lost afterward.</p>	<p>rename the file accordingly to the component item name in the older iCube Engineer version.</p> <p>The file should be contained into <Project Name>/content/...</p> <p><i>note: when using *.pcwex format, the file needs to be unzipped to find the "content" folder.</i></p> <p>Then open in the new iCube Engineer version and proceed to the conversion of the project again.</p>

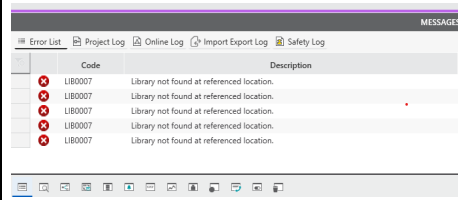
In case the administrator and the local user are two different accounts, and iCube Engineer is being opened from the normal user, the following error will occur: "Library not found at referenced location".

There are 3 possible workarounds in this situations:

1. Start iCube always in *Run As Administrator*, in this case the the default path to look for user libraries in iCube will change to *C:\Users\.*
2. In case you don't want to Run the iCube in Run as Administrator then after running iCube change the path in the iCube software where it looks for the user libraries. For this go to *Extras->Options->Tools->Directories->User Libraries location*.
3. Copy the library from the administrator folder to the user folder.

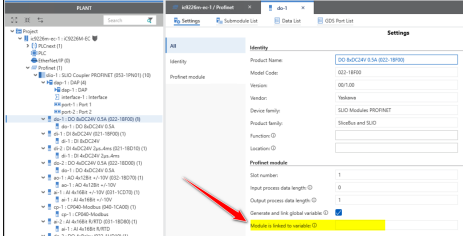
56985	Profinet device integrated via "Online-Devices" has no name for automatically integrated variables	Using the "Online-Device" option to scan Profinet coupler with SLIO module and then use the button "Add to project" create a module with the "Generate link global variable" checkbox checked but no variable linked to it :

Uncheck and recheck the box "Generate and link global variable". This will populate the -> Field "Module is linked to variable...".
57006	Parameter tab missing for Sigma-X drives using catalog entry ending in 0x10002	The parameter tab is missing from device configuration page of Sigma-X drives if revision number 0x10002 of the SigmaX servo is chosen while performing an etherCAT bus scan.	Do not use revision 0x10002 of Sigma-X catalog on an EtherCAT bus scan. Use a newer version consistent with the servo drive firmware.

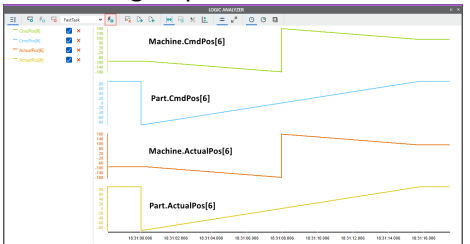
<p>Also, PCS movements where the rotational axis' position crosses 0 might cause a jump in the MCS position, as seen in the following image. The servo will throw an alarm in such a case, stopping the motion of the whole group.</p>

<p>Some possible workarounds are:</p> <ul style="list-style-type: none"> • Do not use a PCS coordinate system • Select target positions that avoid conflicting trajectories • Add middle positions commanded in MCS to avoid conflicting trajectories
