Release Notes for iCube Control Products

Release 2024.3.1

Date: 2024-10-07

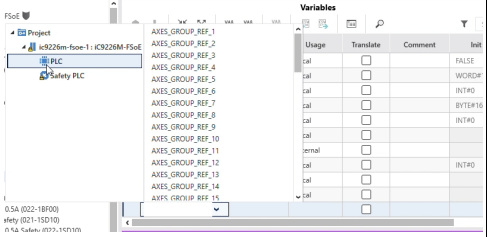
30202	Project Rebuild is required on project open if Profinet VFD devices are in the configuration	Opening a project that contains a Yaskawa profinet VFD (GA500 or GA700) which was working before ends up in Y_MotionAxisDriver with an Error&errorID 13807 .	Execute a Project-->Rebuild, then download the project again.
31416	Global Replace - creates a new variable and keeps the current one that was supposed to be replaced	Global Replace function creates a new variable and keeps the current one that was supposed to be replaced	Manually remove the old variable if it is not required. User could evaluate if 'Refactor' could be used instead of a 'Global Replace'
32554	Access to Safe Variables from Standard PLC	Names of variables from the Safety PLC project will appear in a list of available variables when working in the standard PLC project. This occurs when typing a variable name - see the example below - as well as when browsing the variable names in the drop-down list. If a safety PLC variable is used within the standard PLC project this will cause an error when the project is rebuilt.

When selecting a variable name, first open the variable list drop-down and then select "PLC" to filter only for standard PLC variables.
