# Release Notes for iCube Control Products

Release 2024.9.1

iCube Engineer Version: 2024.9 (Build 6.0.15981.0)

iC9226M-EC Firmware Version: 2024.9.1 (Build 147054)

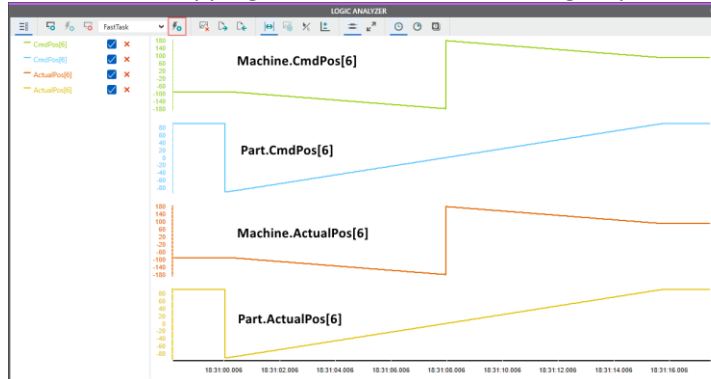
Also, PCS movements where the rotational axis' position crosses 0 might cause a jump in the MCS position, as seen in the following image. The servo will throw an alarm in such a case, stopping the motion of the whole group.

Some possible workarounds are:

- Do not use a PCS coordinate system
- Select target positions that avoid conflicting trajectories
- Add middle positions commanded in MCS to avoid conflicting trajectories
